West Pond Living Shoreline Queens, New York

Chester Zarnoch

Baruch College and Graduate Center

West Pond Living Shoreline

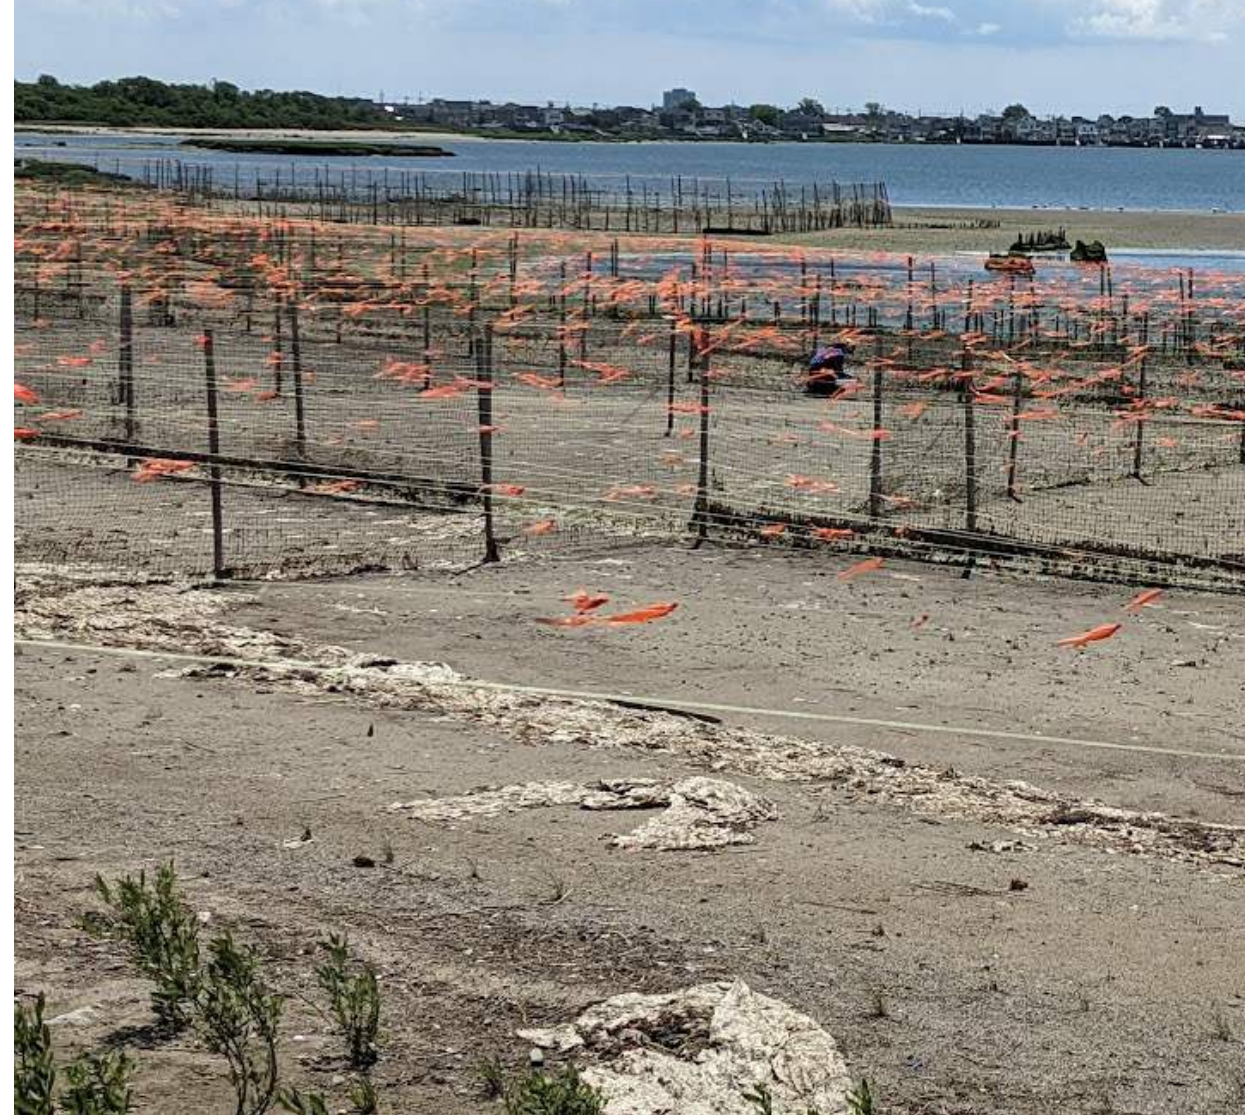
- Breakwater features
4,900 bags of shell

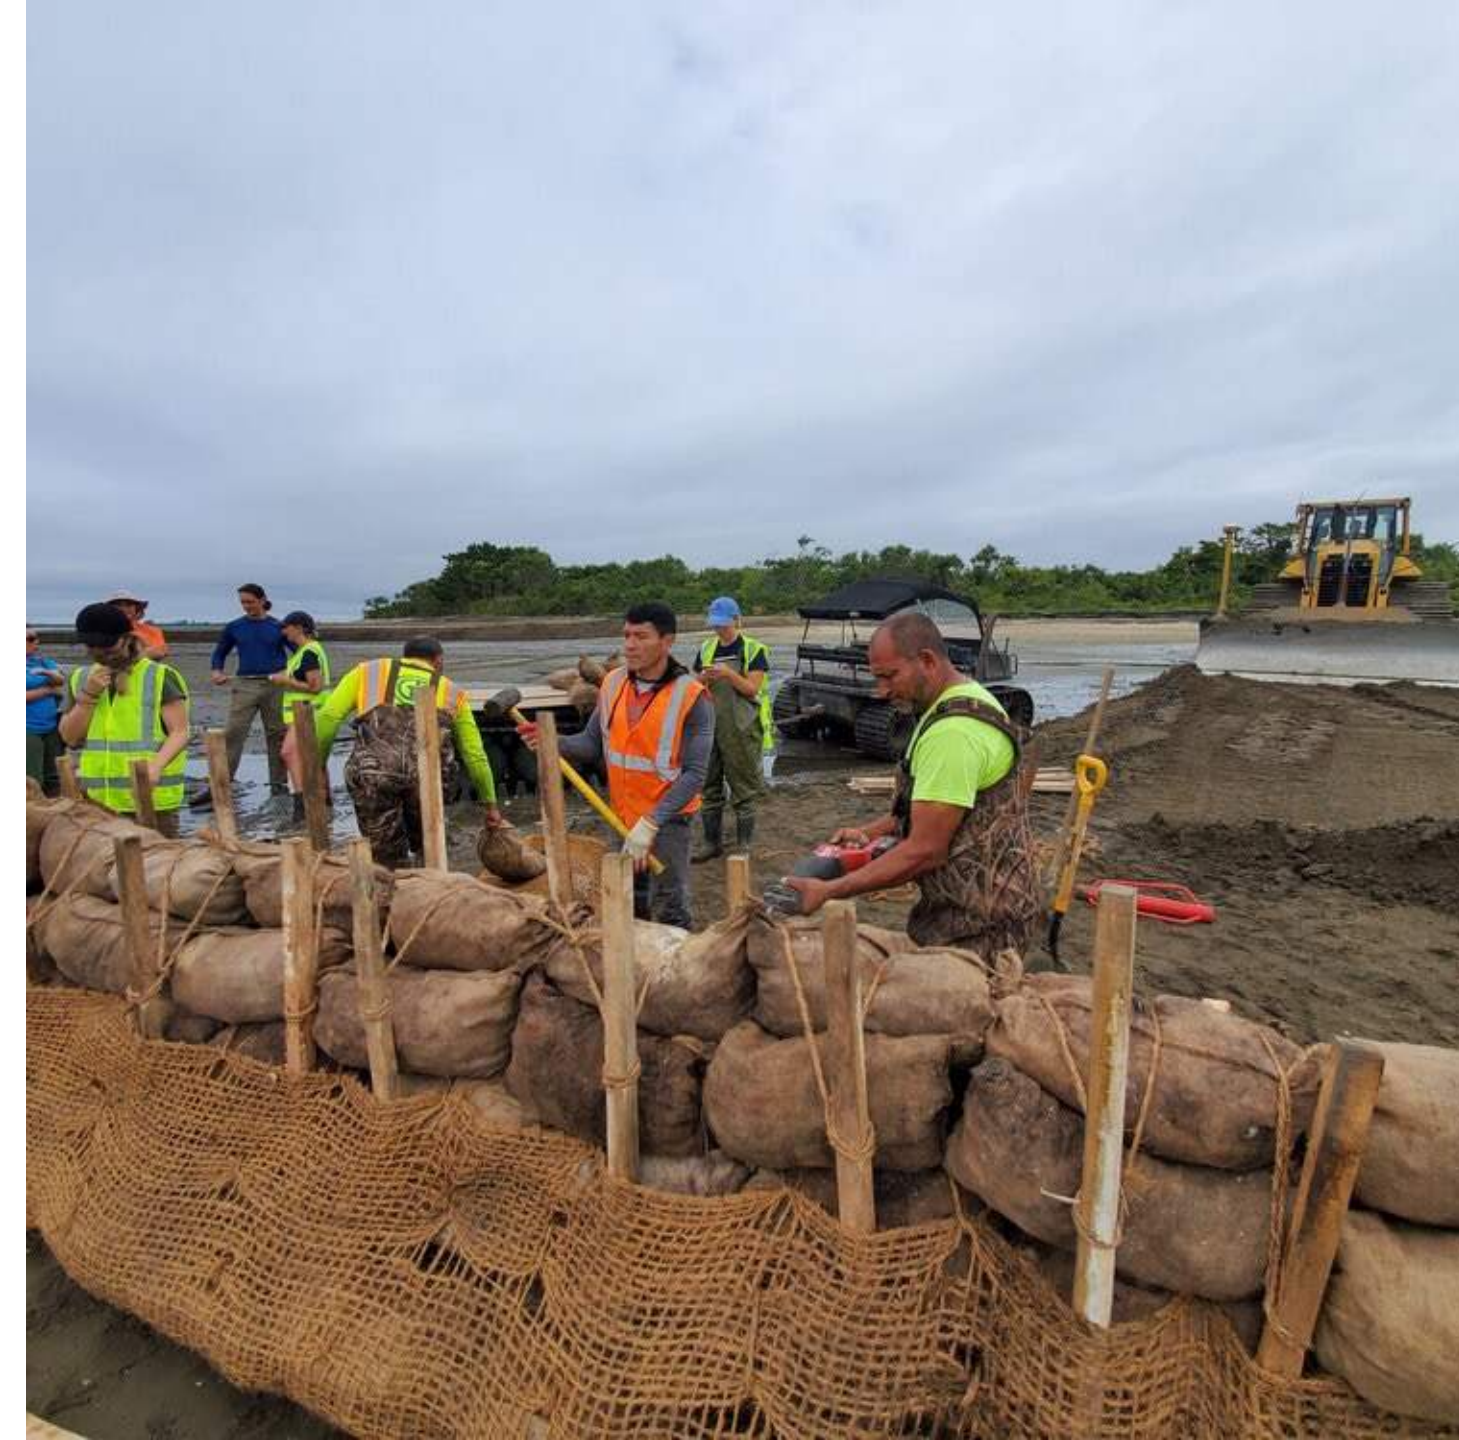
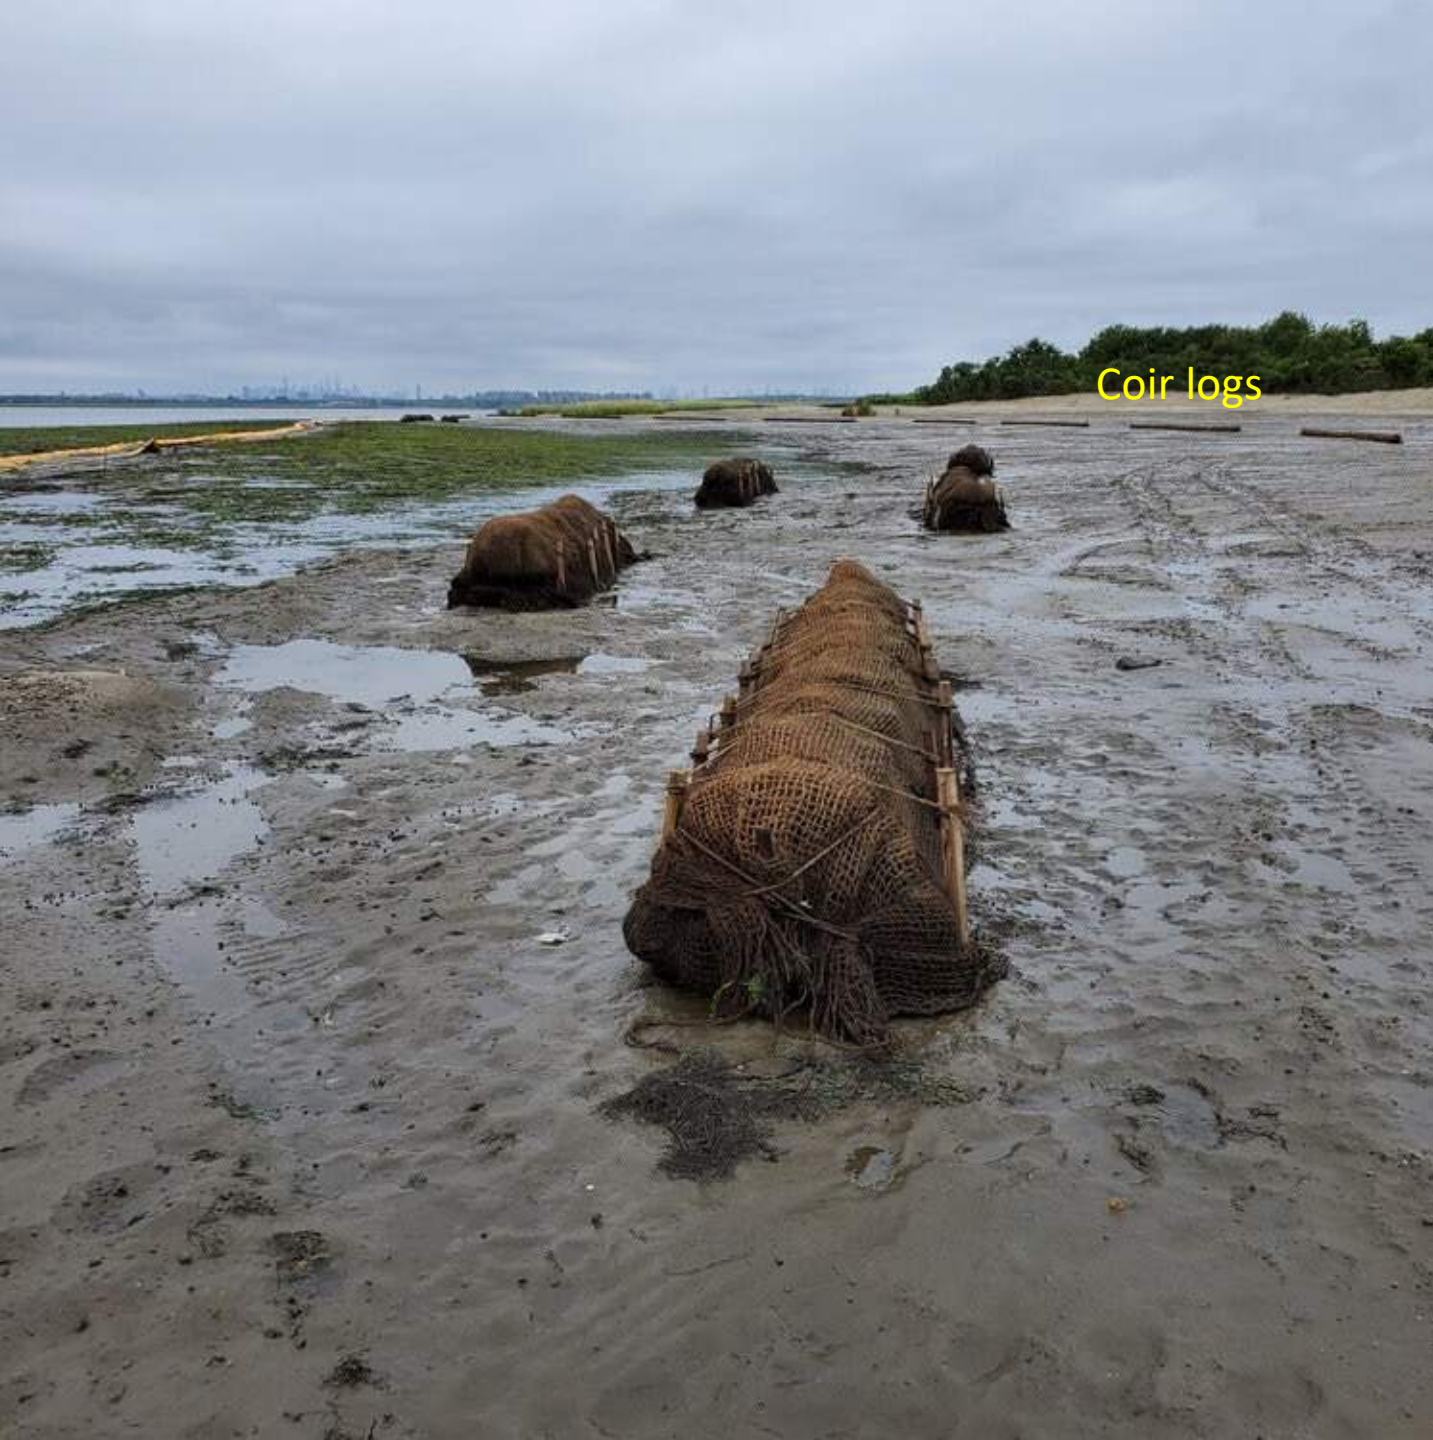
Coir logs

- Erosion Control
-20”w and 12”w coir logs

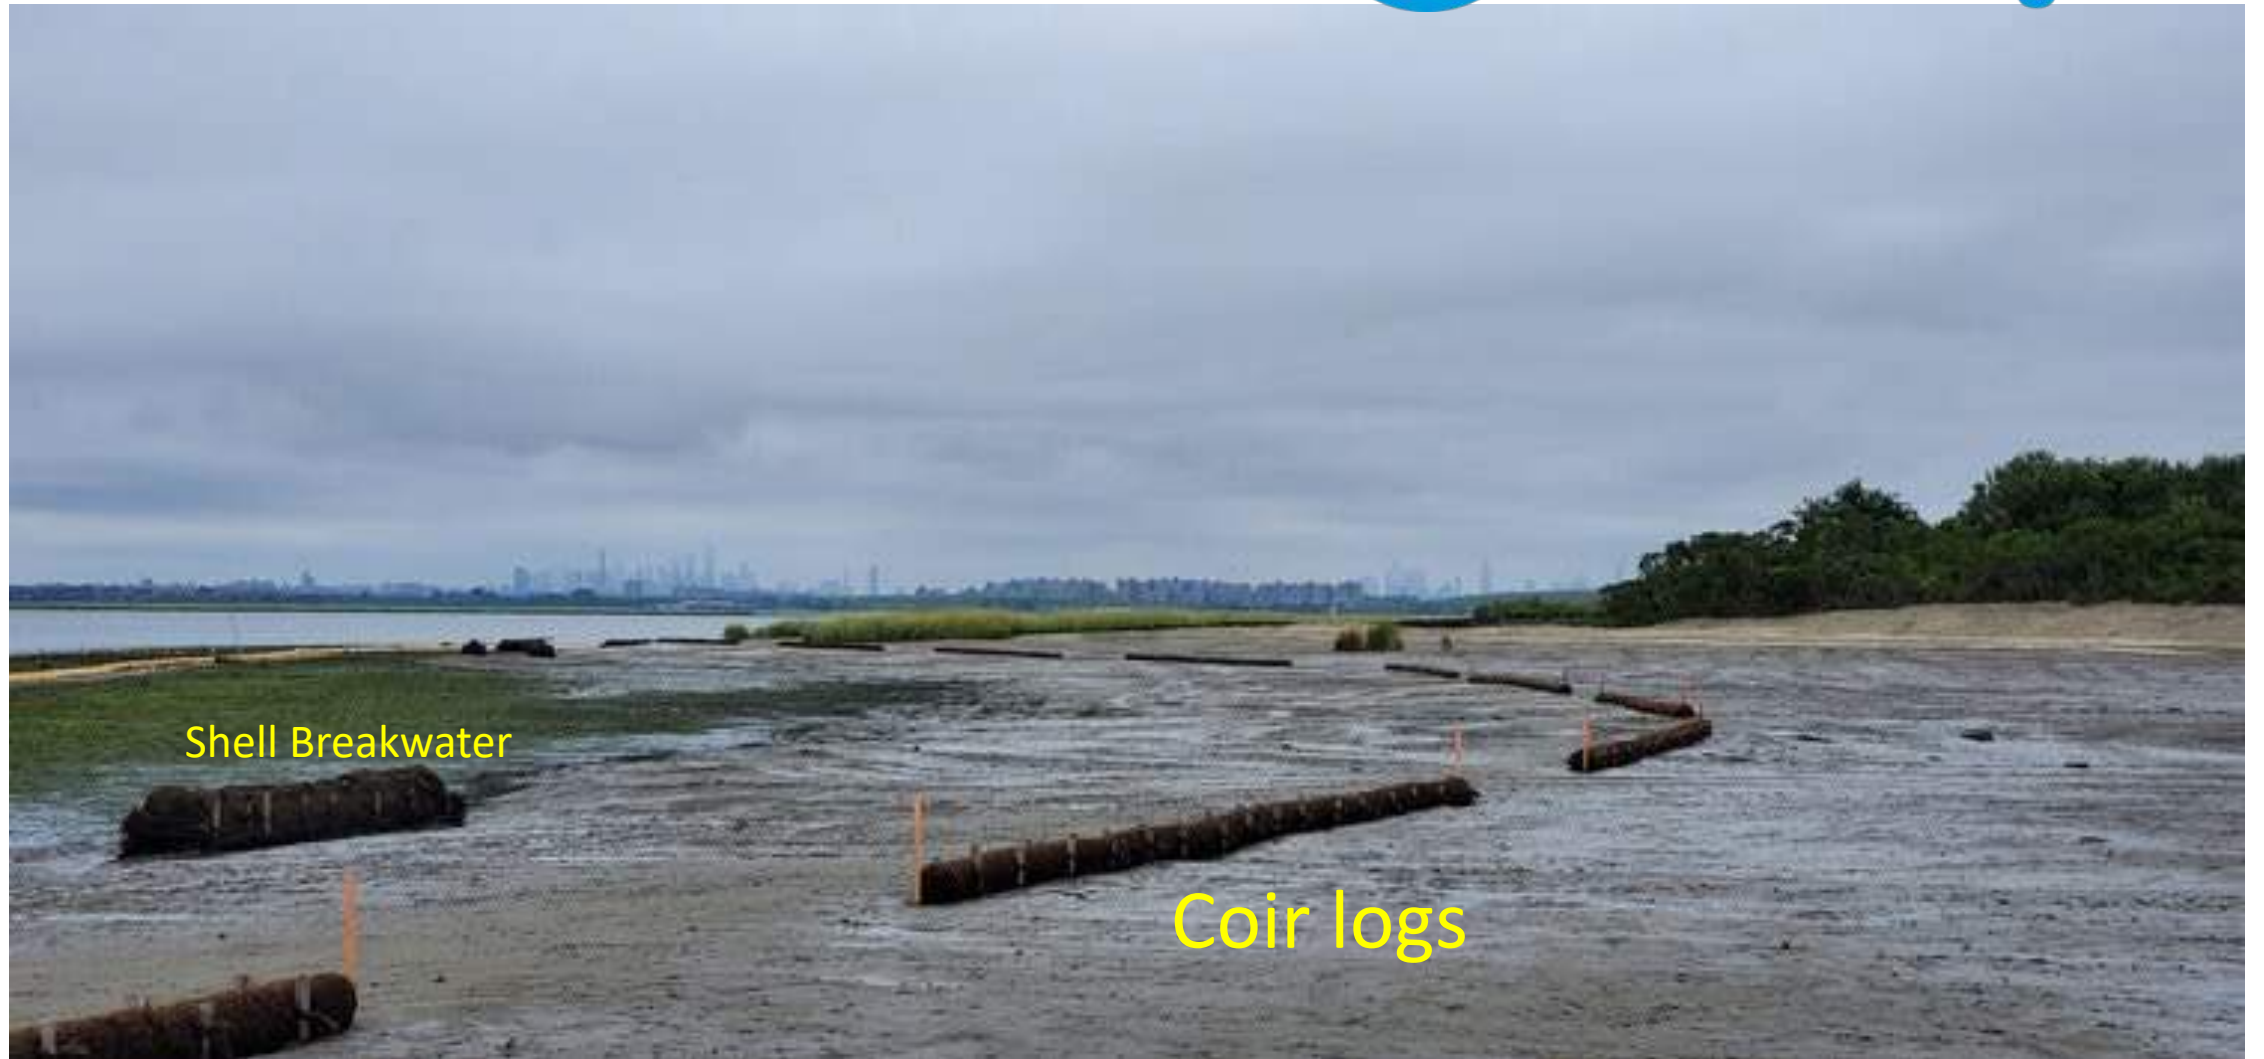
Shell Breakwater

Coir logs

2021

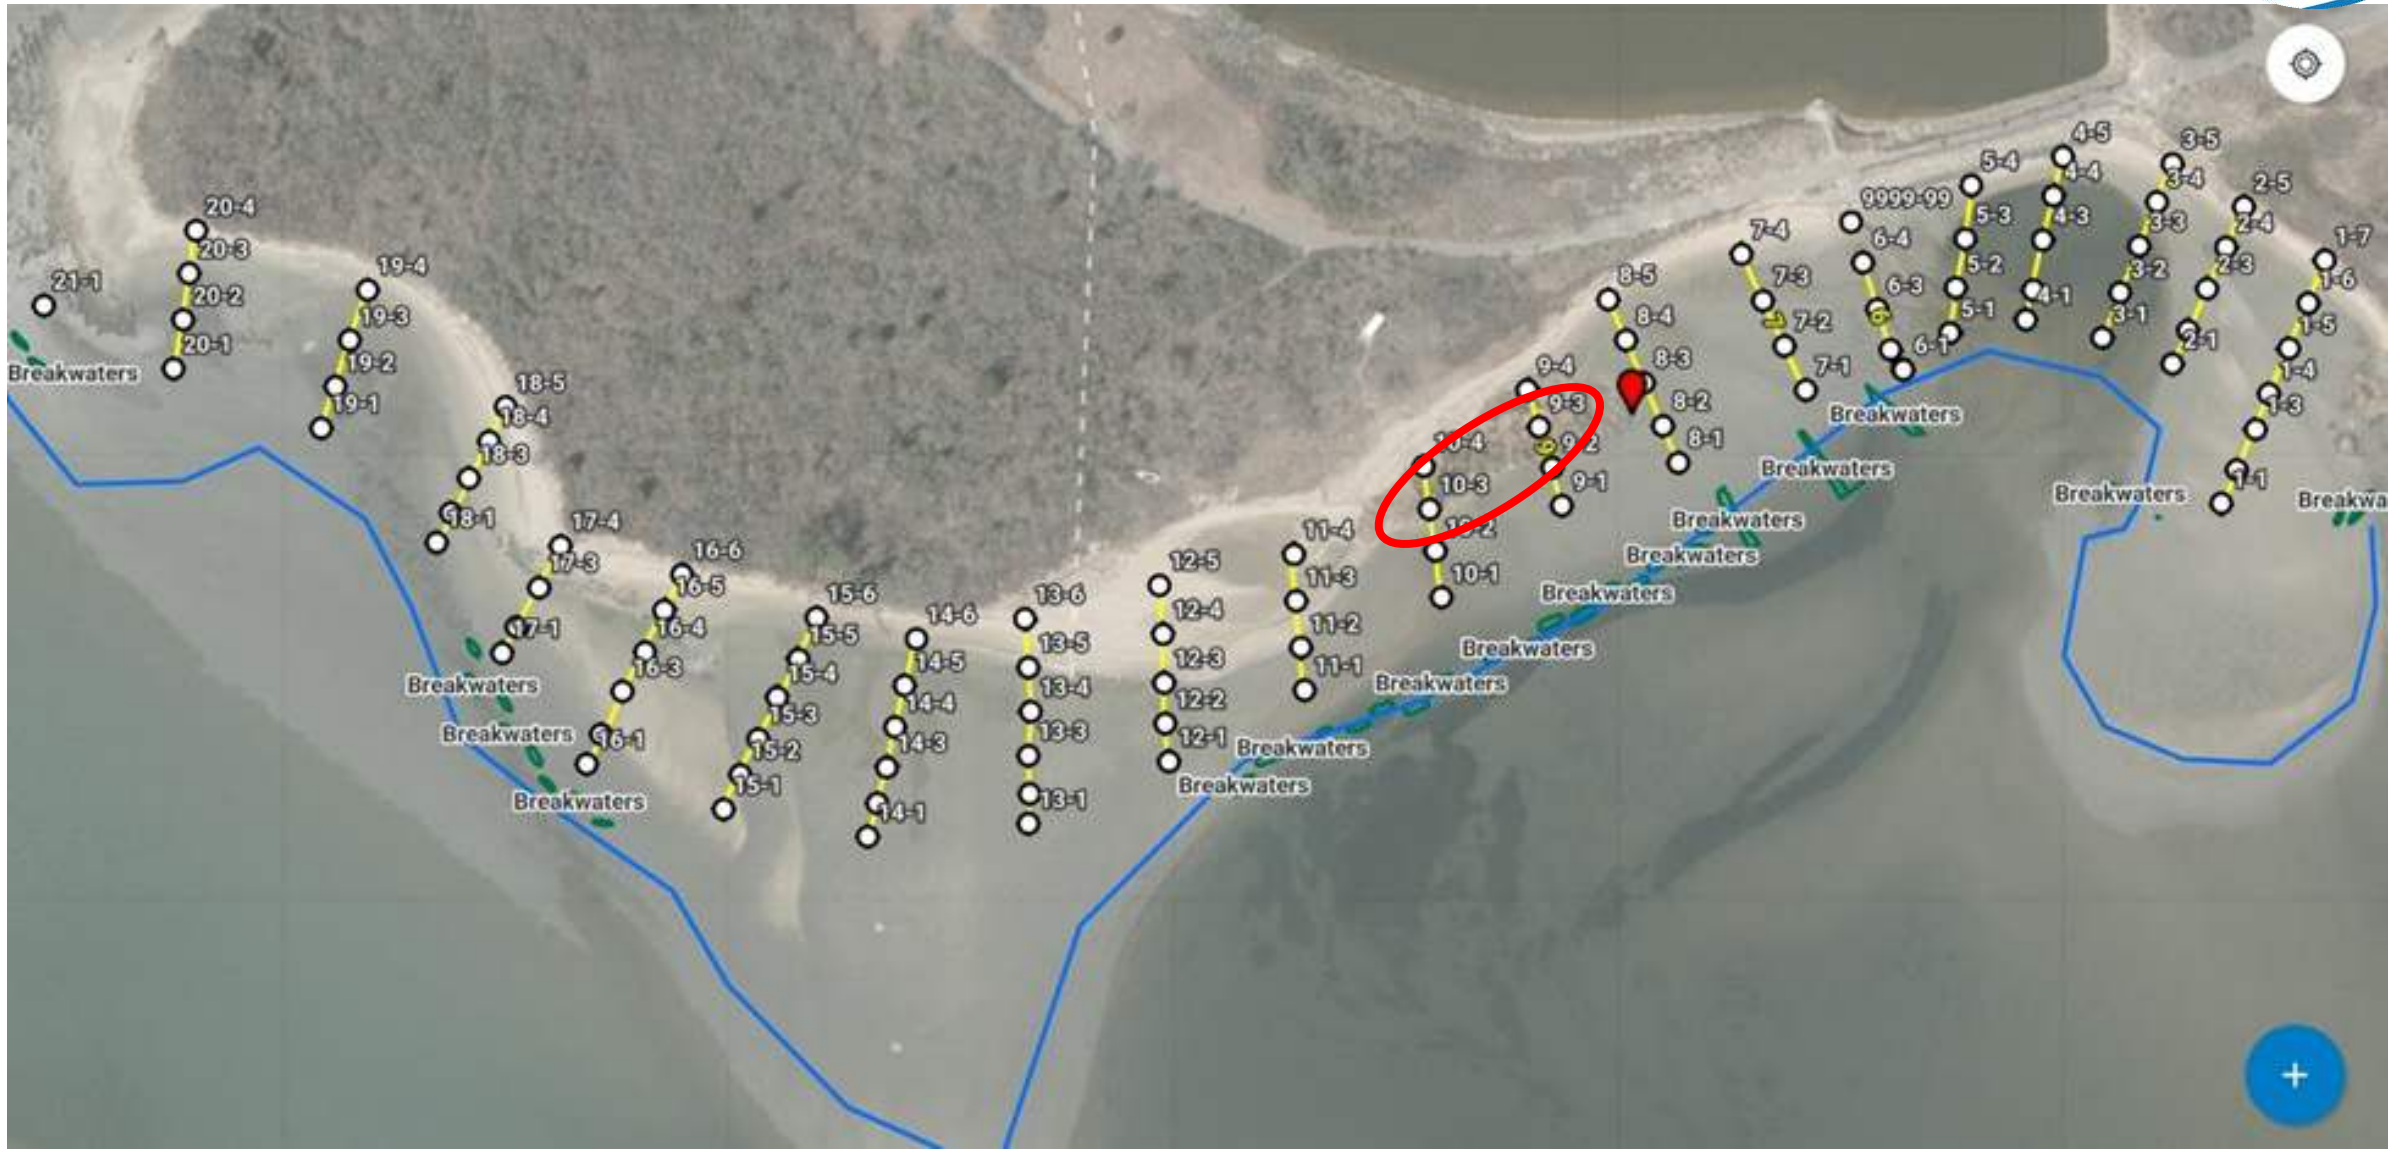
Elevation across monitoring points in 2022

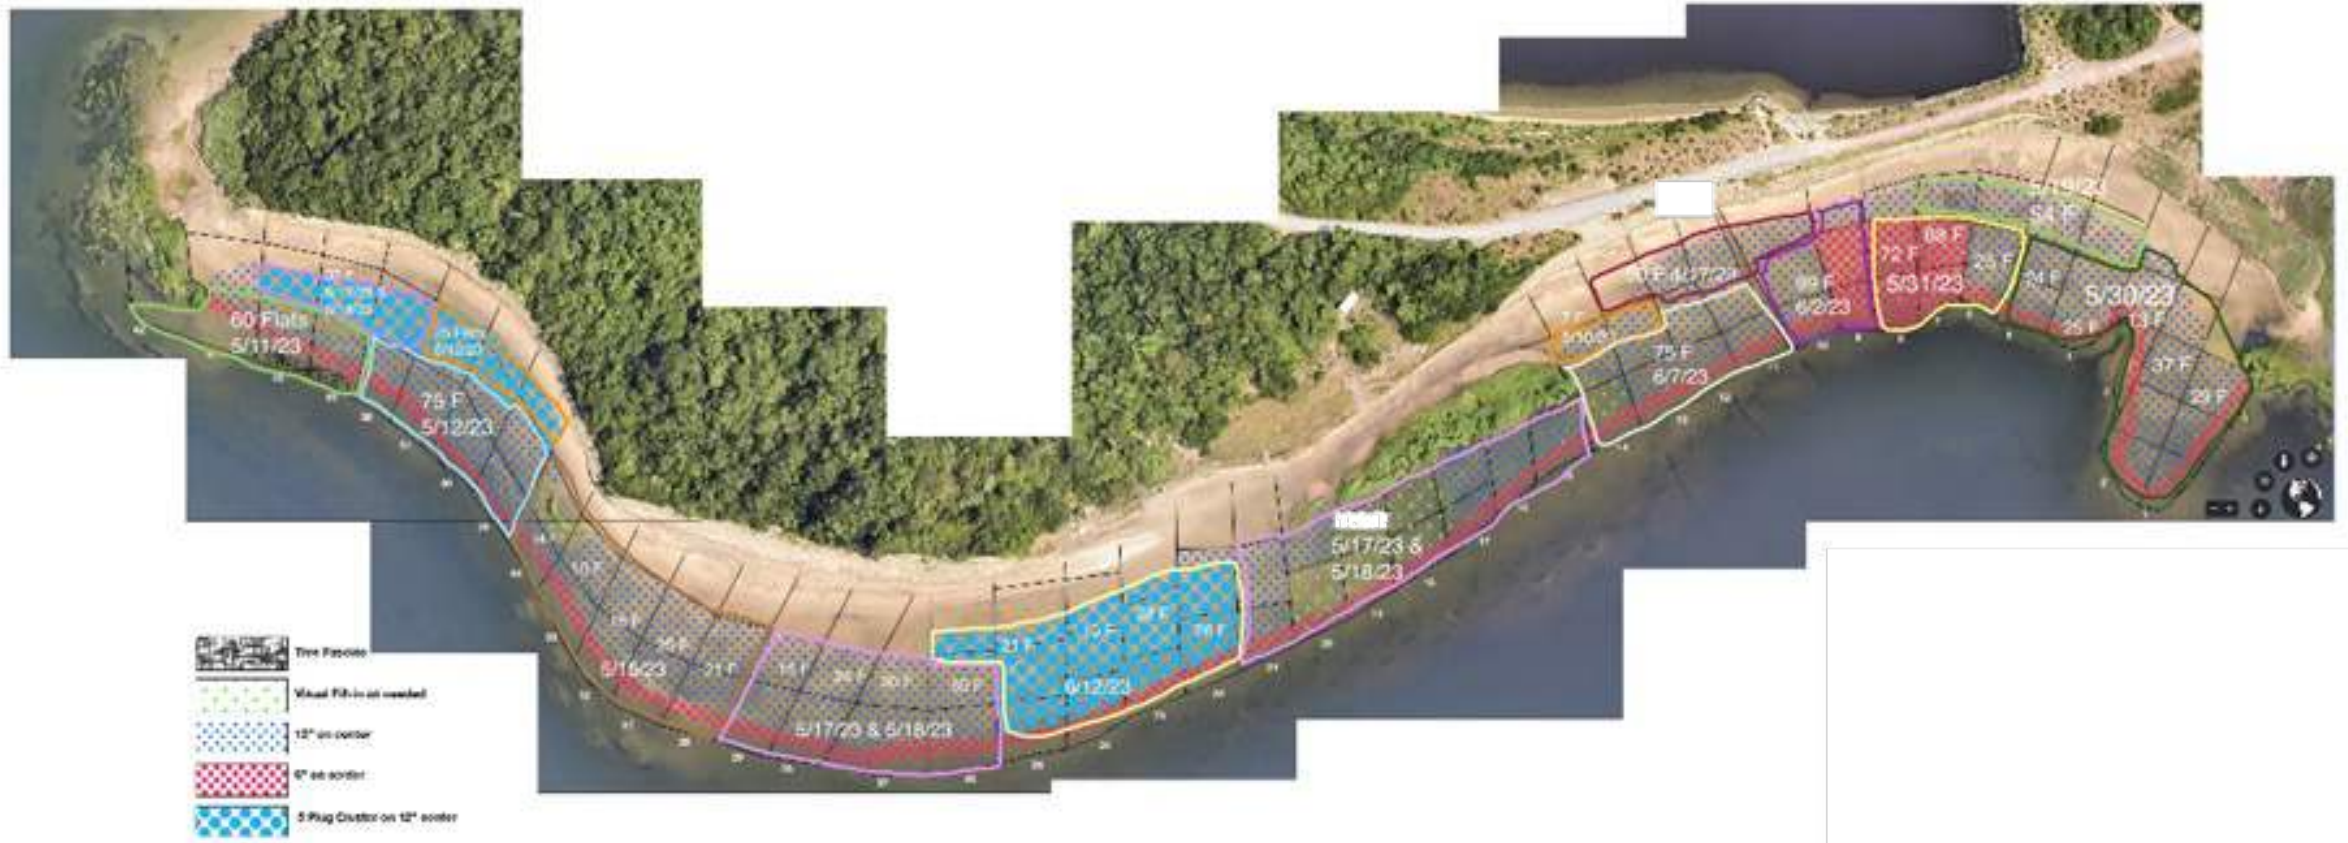
West Pond Living Shoreline Replanting Plan – June 2023

2023 Replanting- 60,000 plugs

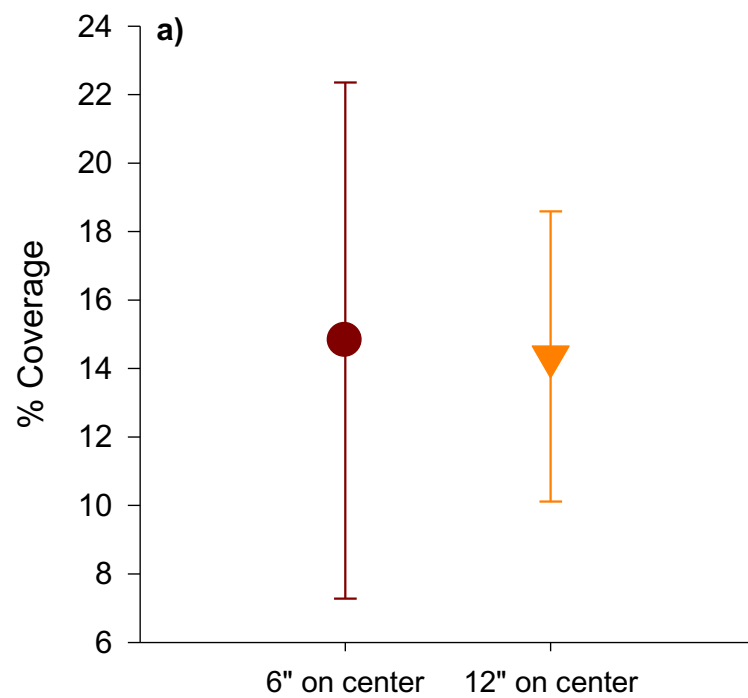
Planting technique did not improve vegetation 6" on center vs 12" on center

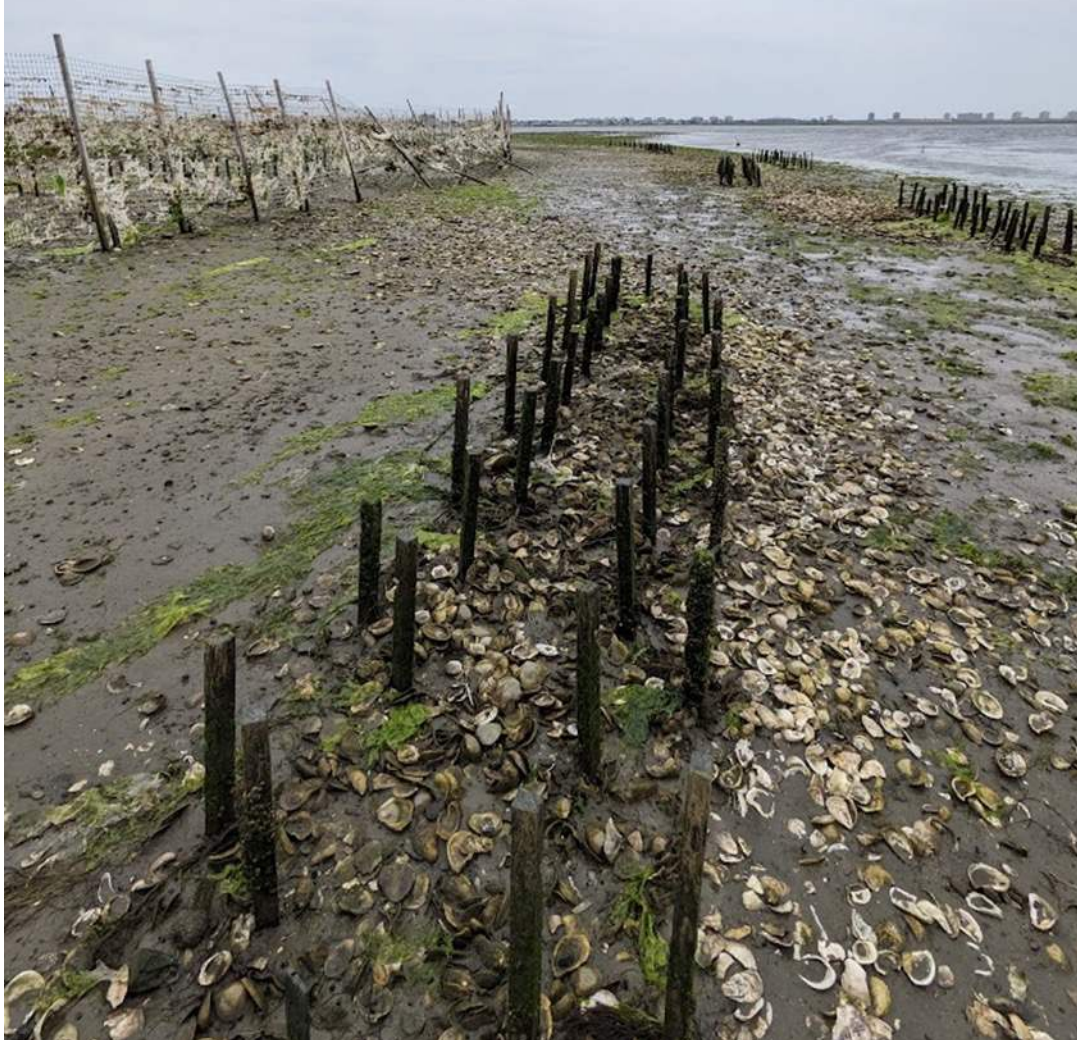
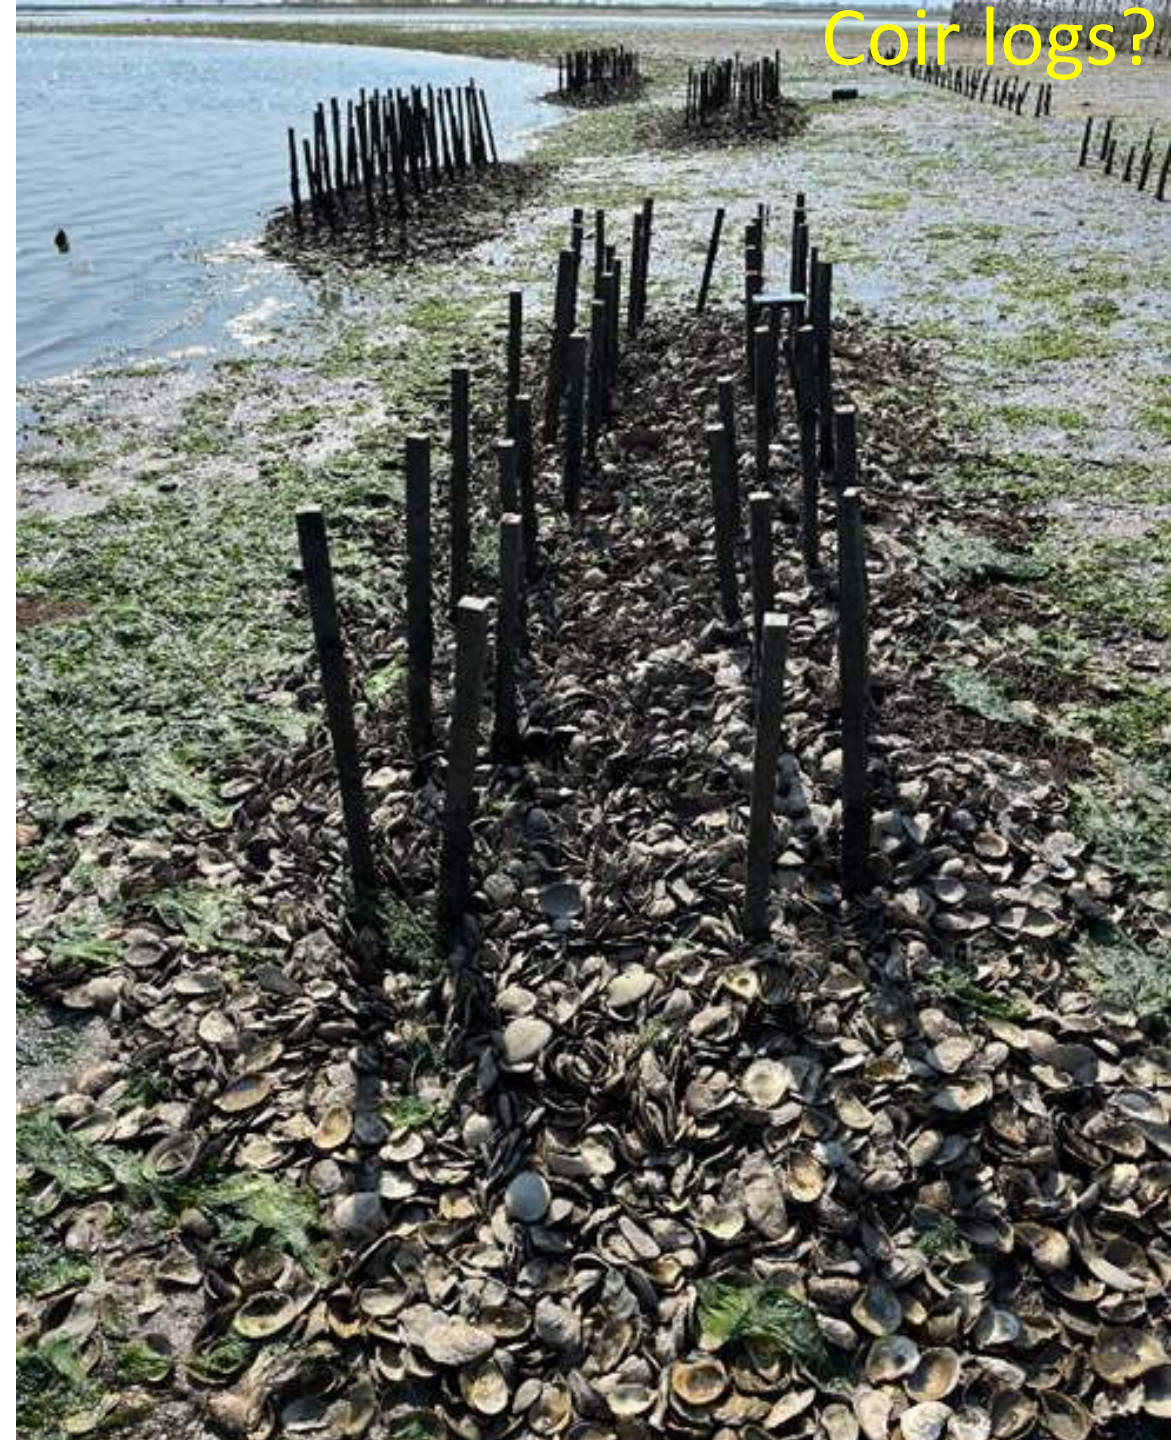
Project Challenges –
Shell bags degraded &
All coir logs were lost < 1yr

- Ongoing maintenance is key
 - Herbivore exclusion fencing
 - Replanting
- Spring planting performed better than fall planting
- Elevation is critical but one of many factors driving plant success
- Wind & Waves may leave some habitat without vegetation
 - Breakwaters may be needed

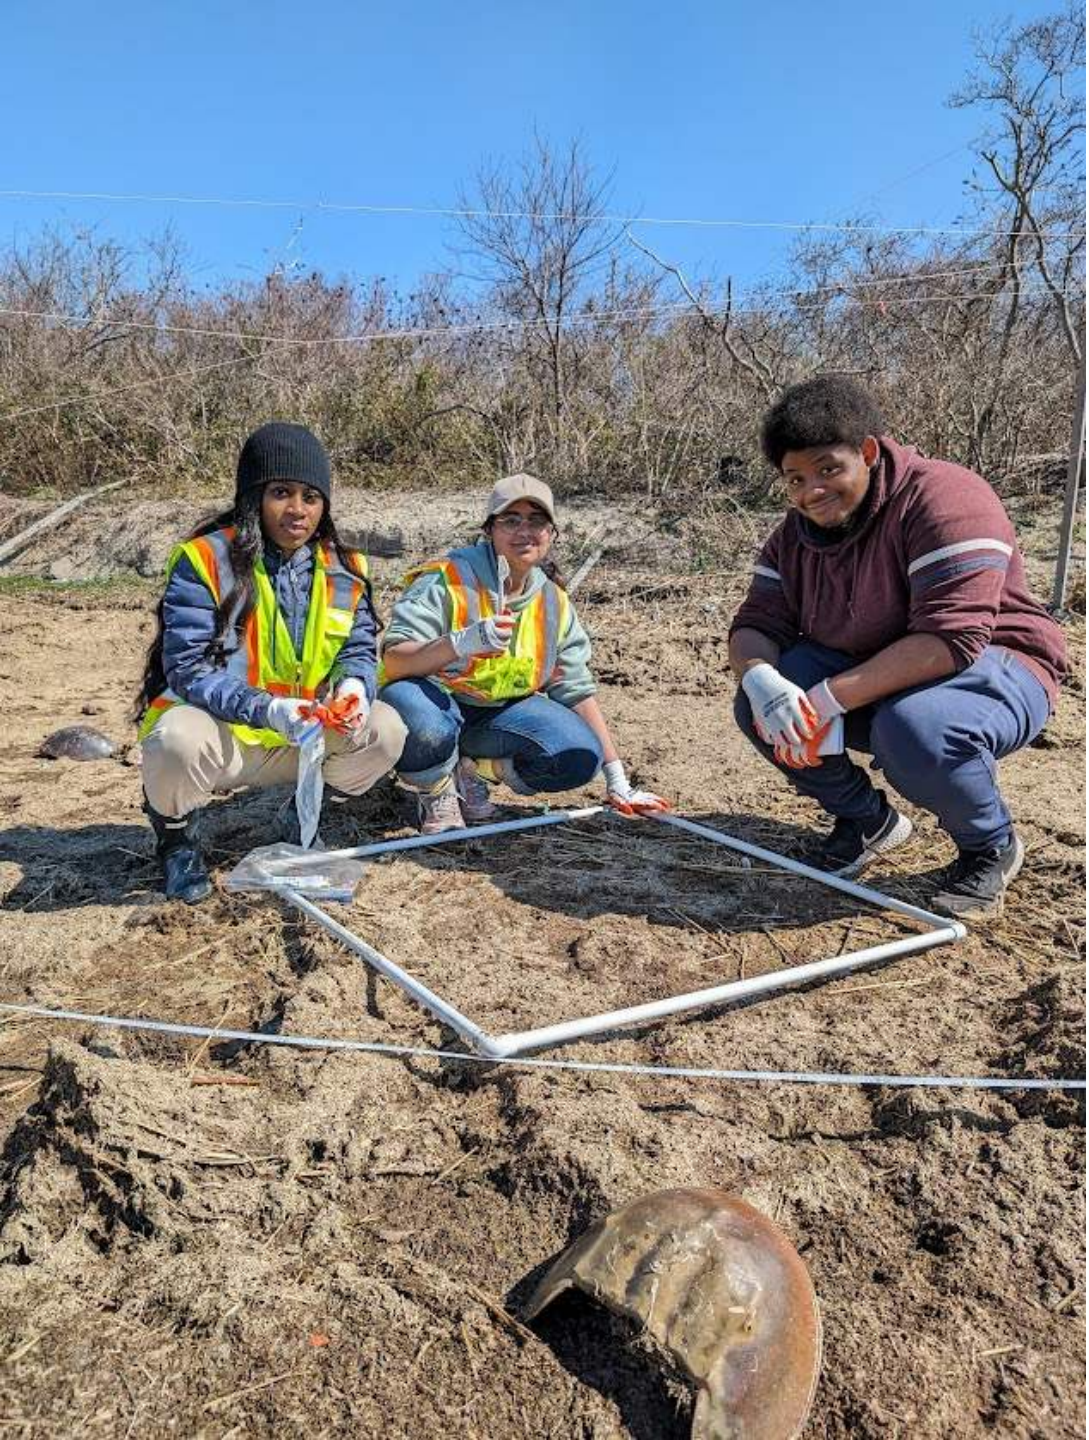
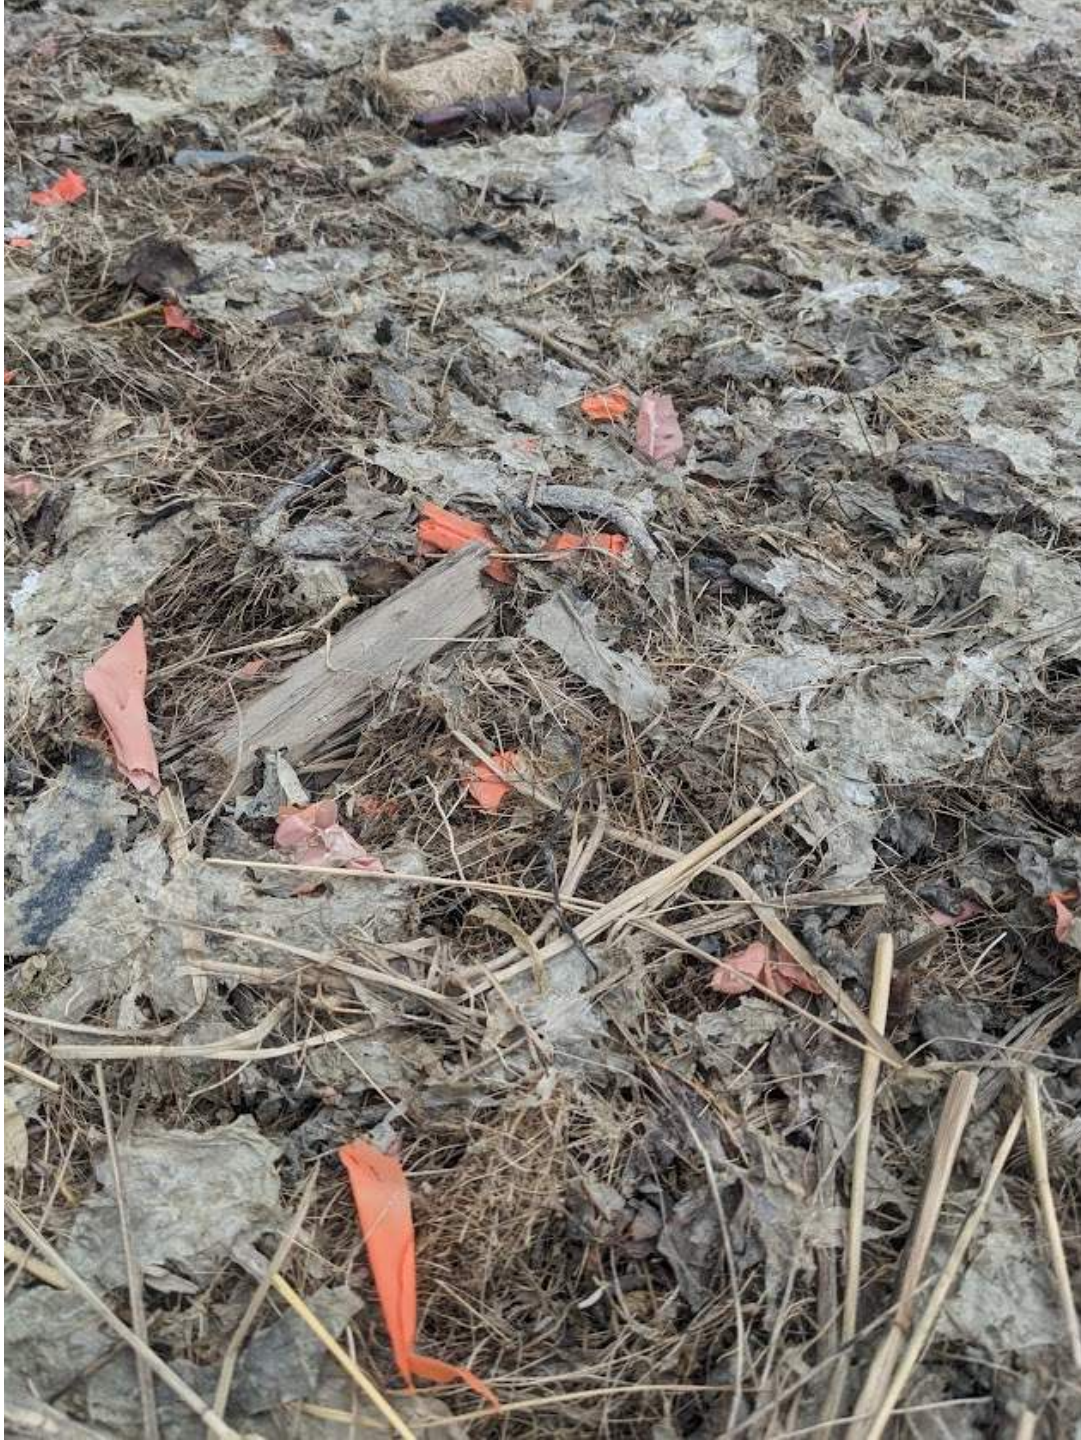
Hypothesis: Herbivore exclusion fencing will trap litter and create a “hot-spot” of litter accumulation.

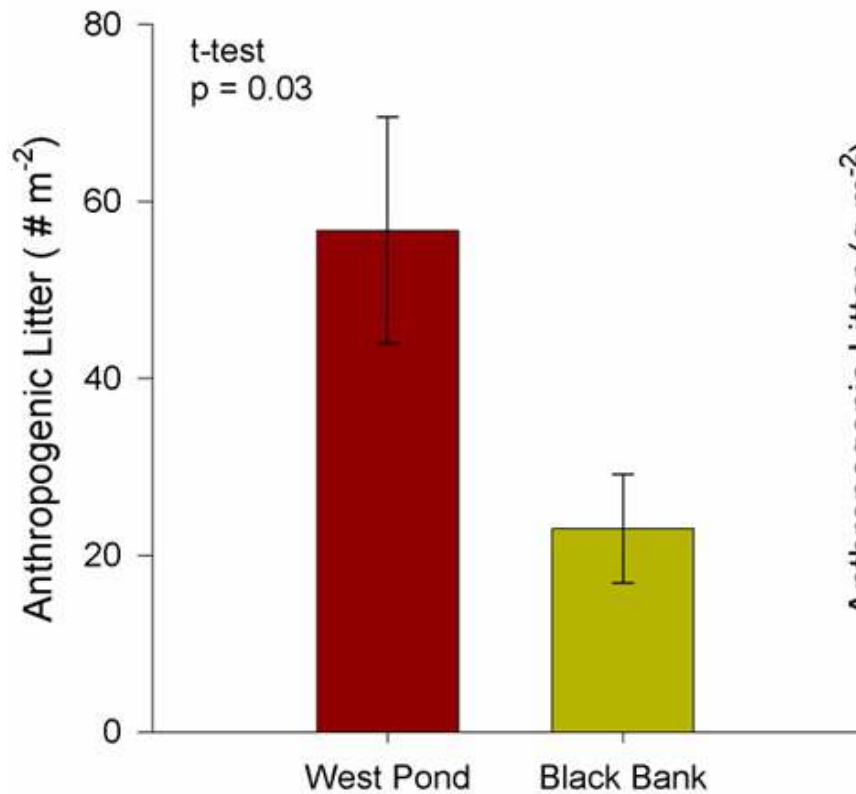
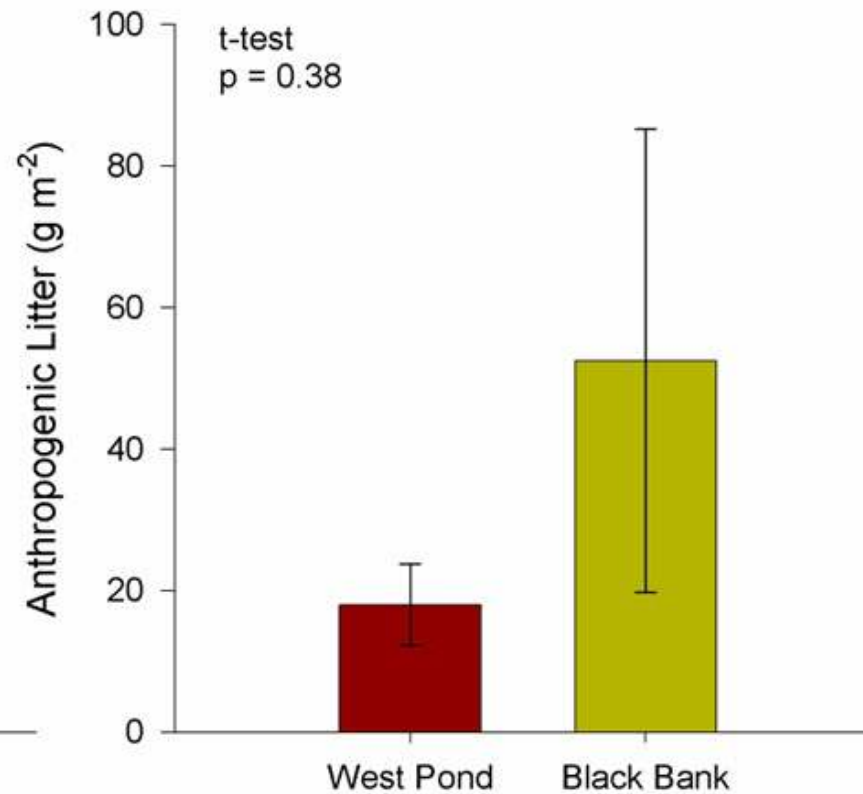
- Significantly more litter in West Pond than natural marsh.
- Litter was heavier in the natural marsh.

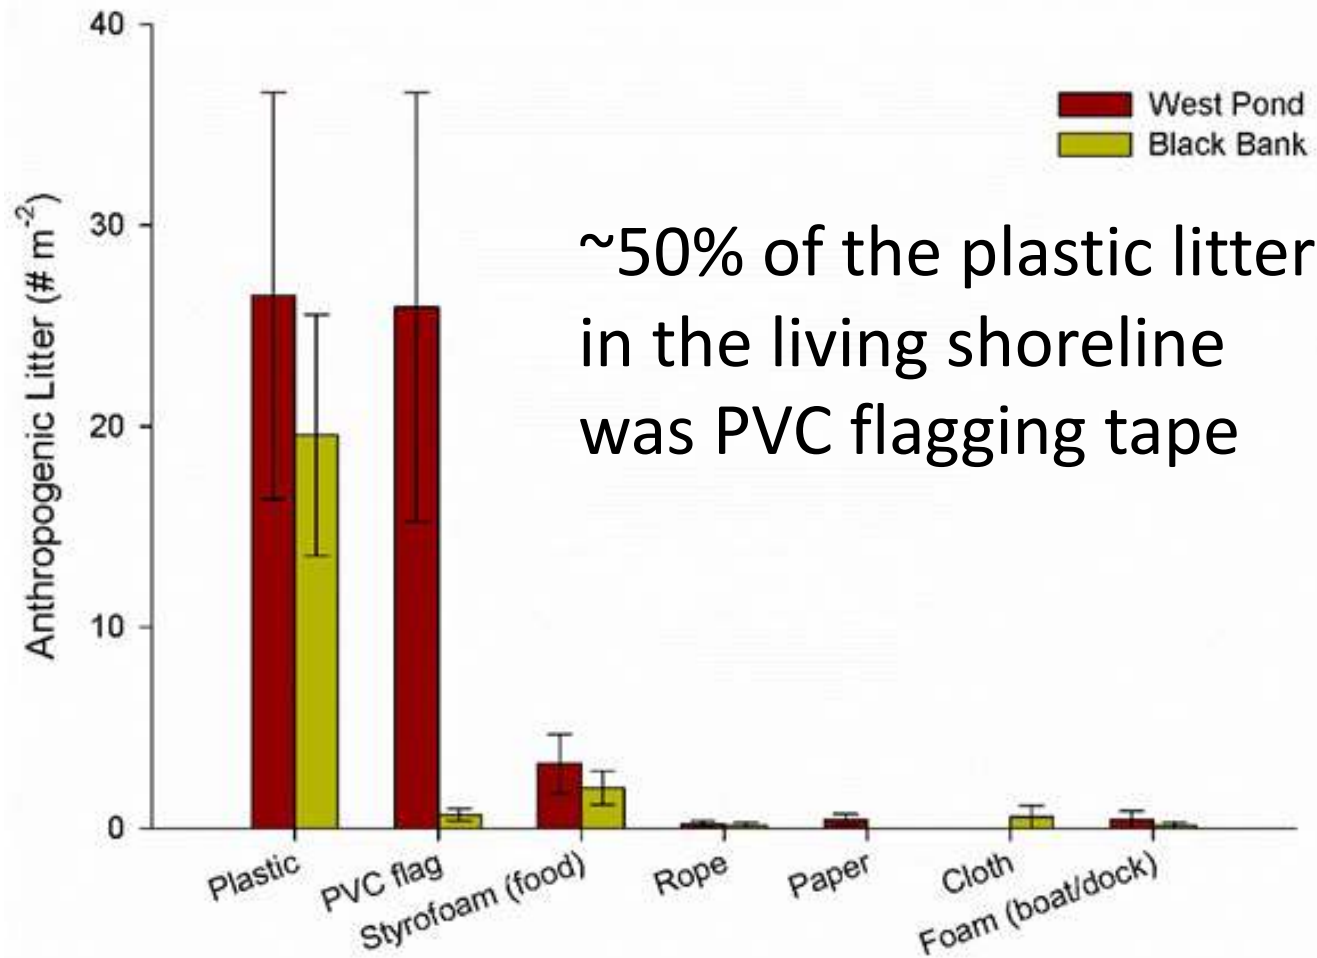
~50% of the plastic litter in the living shoreline was PVC flagging tape
