West Pond Living Shoreline Queens, New York

Chester Zarnoch

Baruch College and Graduate Center

West Pond Living Shoreline

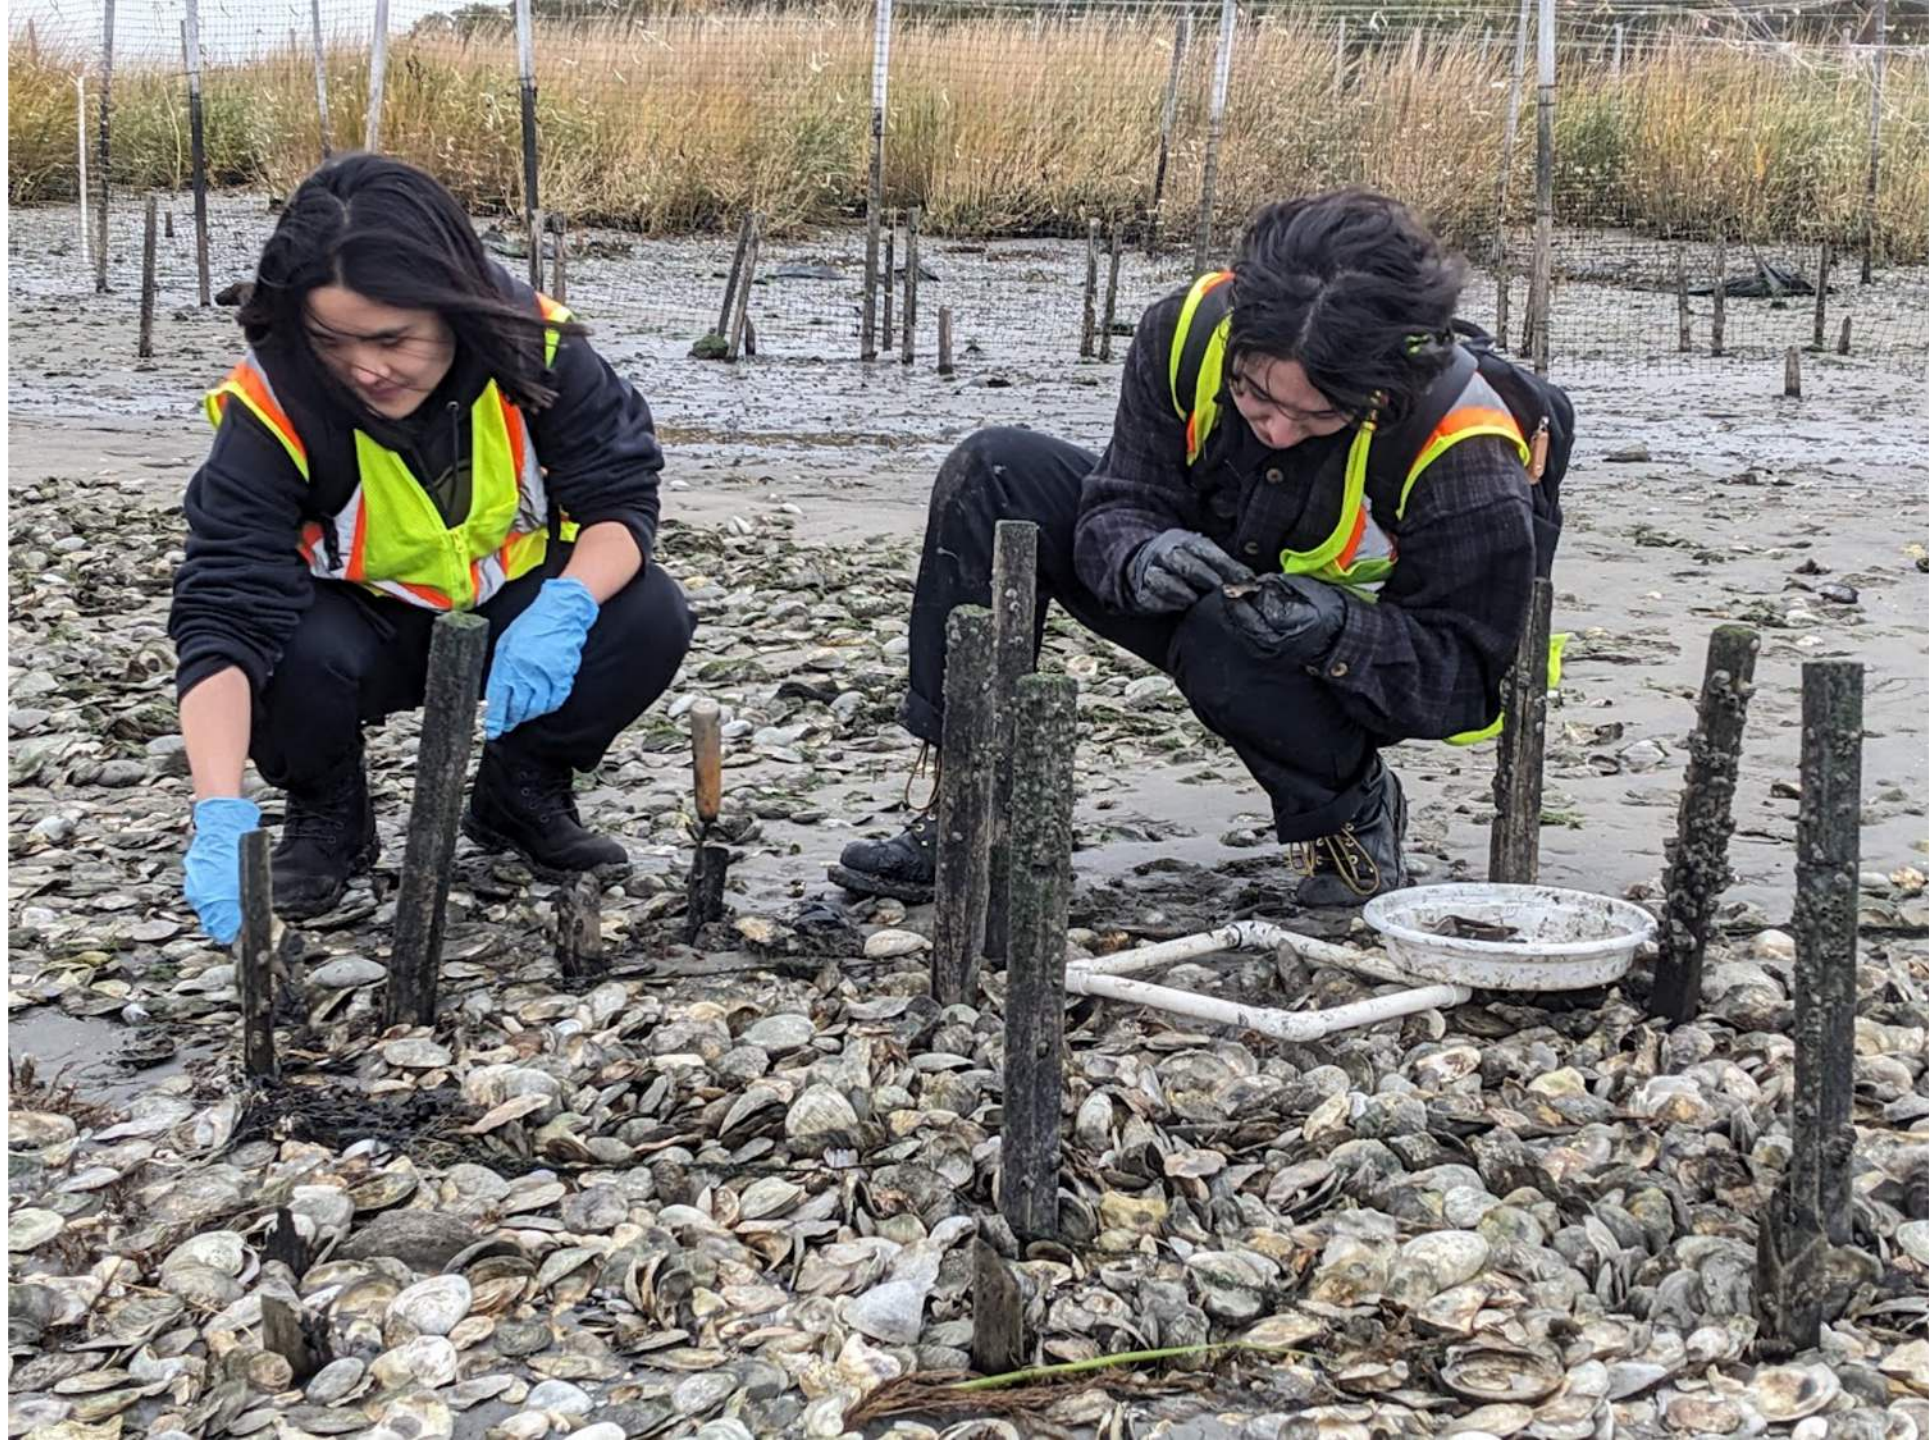
Invertebrate biodiversity study West Pond Shell Mounds

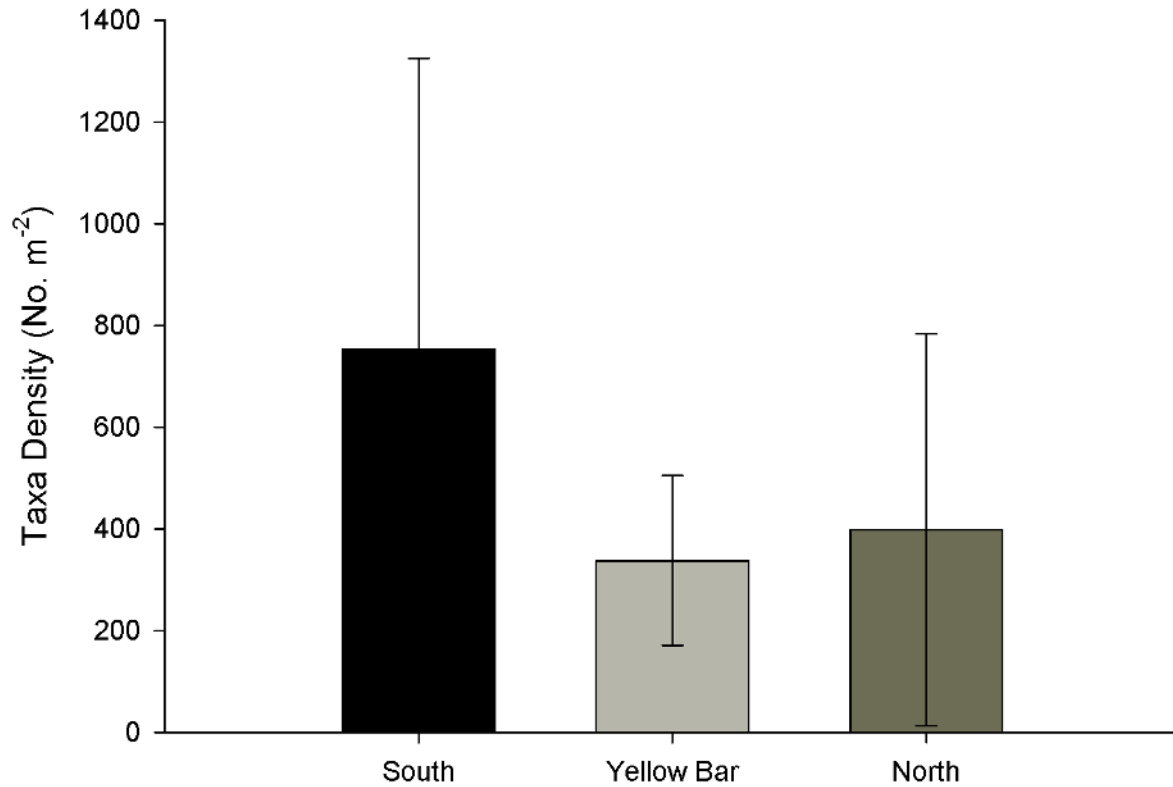
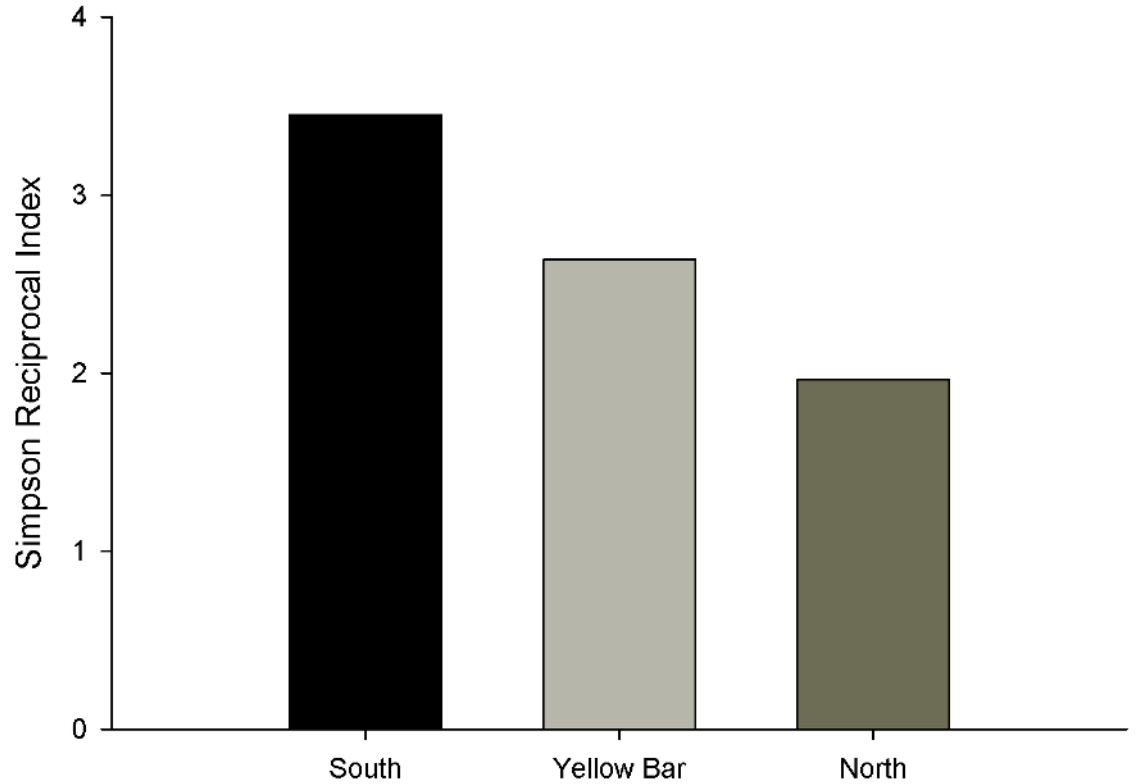
Vertical complexity increased invertebrate density and biodiversity
